**ST. JOHN'S  
EPISCOPAL  
CHURCH**  
REVERE ST  
JAMAICA PLAIN, MA

Date: OCTOBER 1, 2010  
Scale:  
Drawn by:  
Checked by:  
Project Number: 1012.00

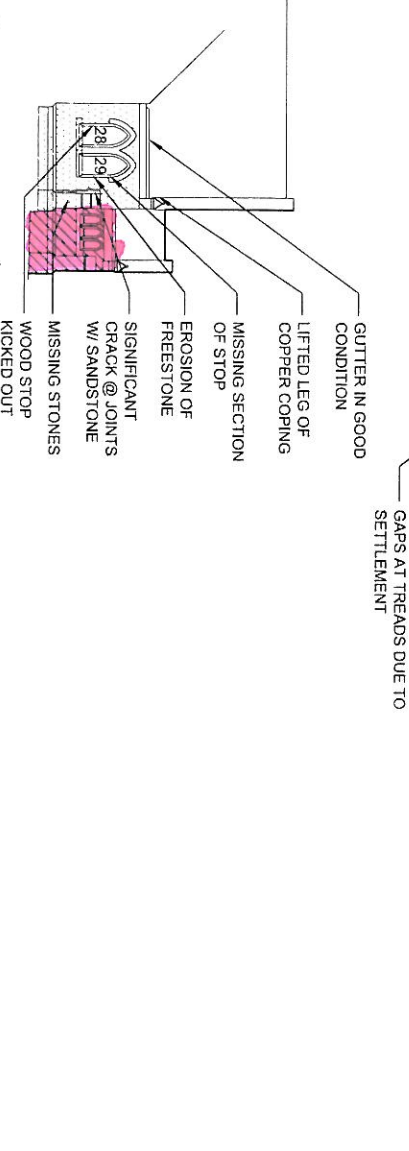
**2 PARTIAL SOUTH ELEVATION**  
1/16" = 1'-0"

WORN & PEELING PAINT  
AGED LEAD CAP FLASHING  
AGED GUTTER PAINTED RED  
EFFLORESCENCE  
ALL 5 WINDOWS MISSING WOOD STOPS  
LIFTED SECTION OF RIDGE CAP  
CRACKED & LOSS OF STONE  
DAMAGED GUTTER FROM SNOW AND ICE  
DISPLACED COPING  
MISSING SECTION OF STOP  
WOOD STOPS HACKED OFF  
NOTE: LARGE GUTTER EXHIBITS NO SNOW & ICE RELATED DAMAGE  
WOOD STOPS HACKED OFF  
SERIOUS SETTLEMENT  
MISSING DOWNSPOUT  
CRACKED STONE  
WOOD STOPS HACKED OFF  
GAPS AT TREADS DUE TO SETTLEMENT  
GUTTER IN GOOD CONDITION  
LIFTED LEG OF COPPER COPING  
MISSING SECTION OF STOP  
EROSION OF FREESTONE  
SIGNIFICANT CRACK @ JOINTS W/ SANDSTONE  
MISSING STONES  
WOOD STOP KICKED OUT
