**ST. JOHN'S  
EPISCOPAL  
CHURCH**  
REVERE ST  
JAMAICA PLAIN, MA

Date: OCTOBER 1, 2010  
Scale:  
Drawn by:  
Checked by:  
Project Number: 1012.00

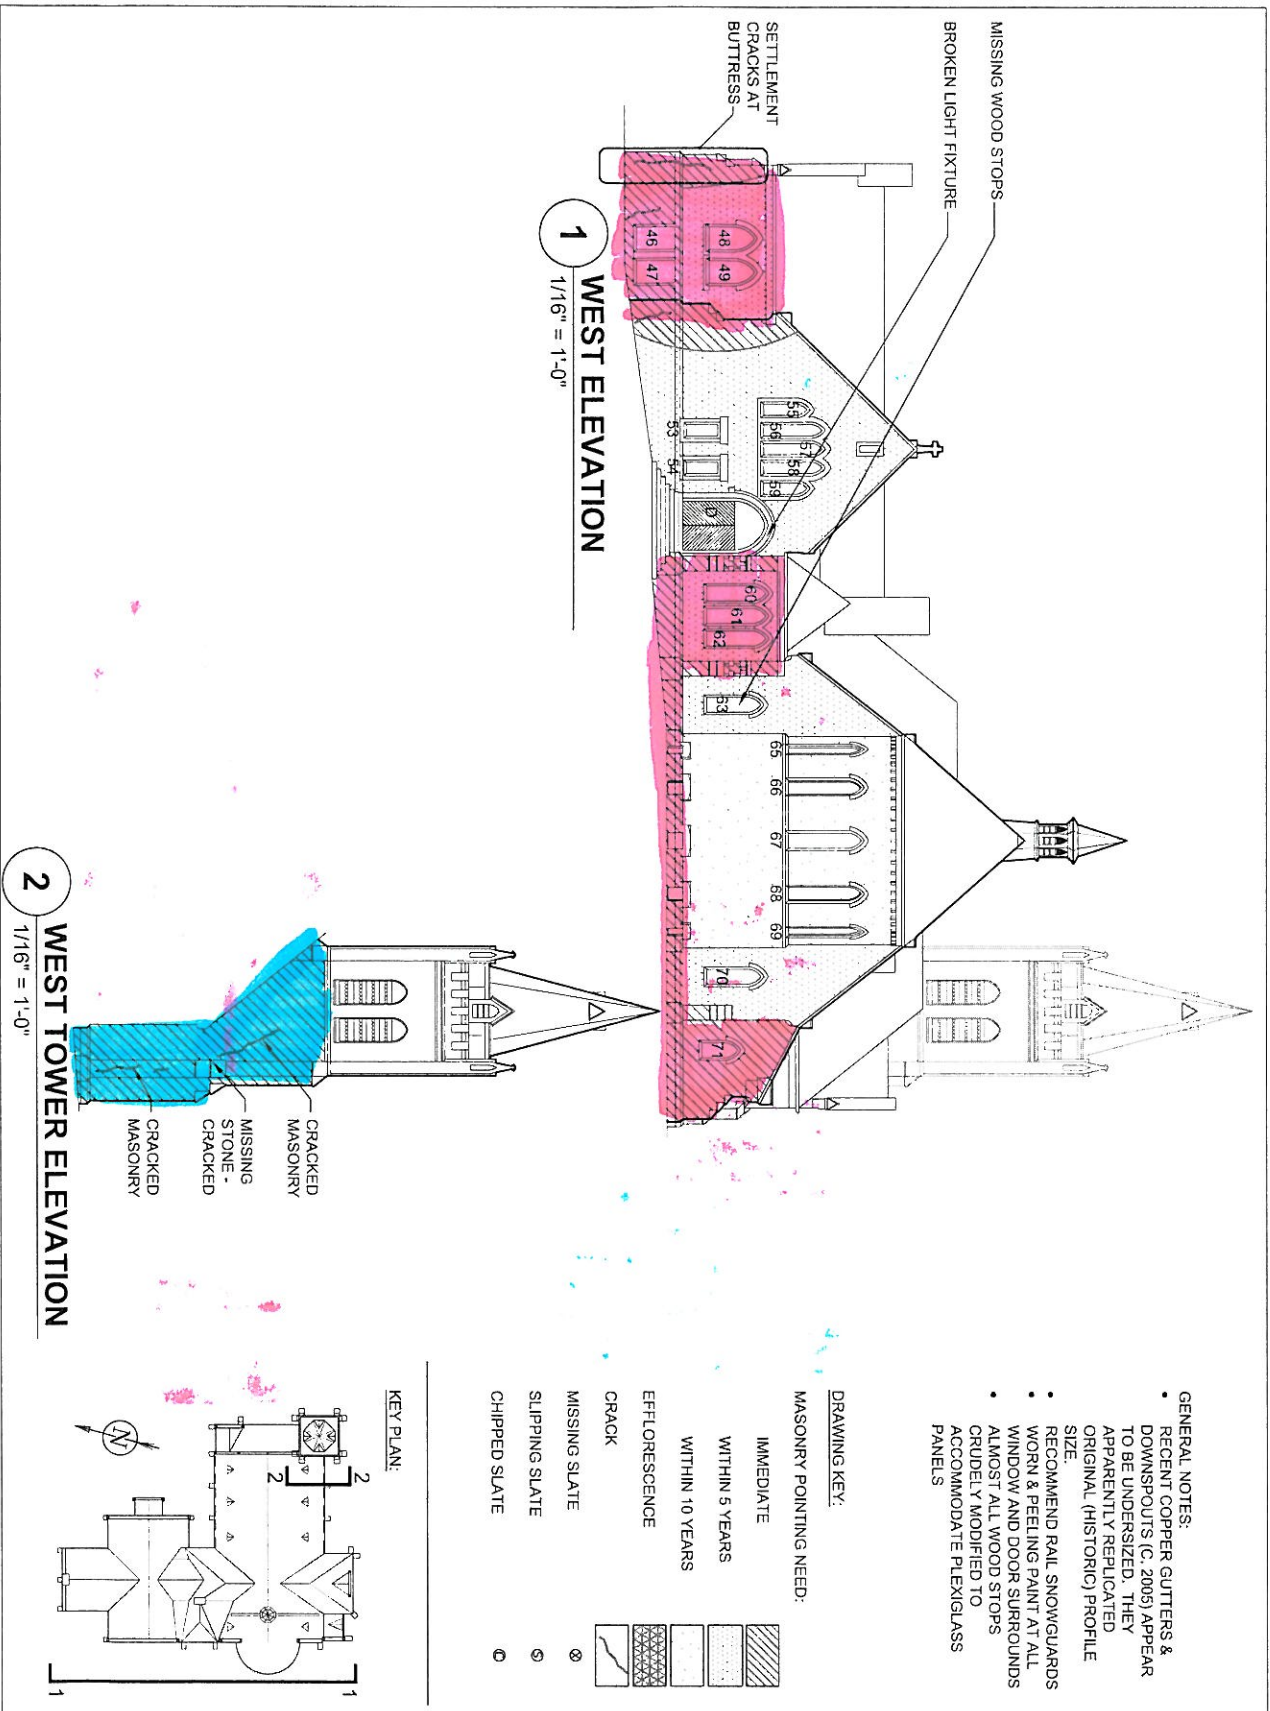
**1**  
WEST ELEVATION  
1/16" = 1'-0"

- GENERAL NOTES:**
- RECENT COPPER GUTTERS & DOWNSPOUTS (C. 2005) APPEAR TO BE UNDERSIZED. THEY APPARENTLY REPLICATED ORIGINAL (HISTORIC) PROFILE SIZE.
  - RECOMMEND RAIL SNOWGUARDS WORN & PEELING PAINT AT ALL WINDOW AND DOOR SURROUNDS
  - ALMOST ALL WOOD STOPS CRUDELY MODIFIED TO ACCOMMODATE PLEXIGLASS PANELS
